RE: Site Inspection, Hiko Bell Mining Company, Pebble Puppy 1 Project, S/047/050
(formerly known as S/047/049 – file closed & archived), Uintah County, Utah

Date of Inspection: May 14, 2001
Time of Inspection: 1335 - 1410
Conditions: mostly clear, warm
Participants: Pete Sokolosky, BLM; Tony Gallegos, DOGM

Purpose of Inspection: To document the current status of the site and discuss the proposed reclamation

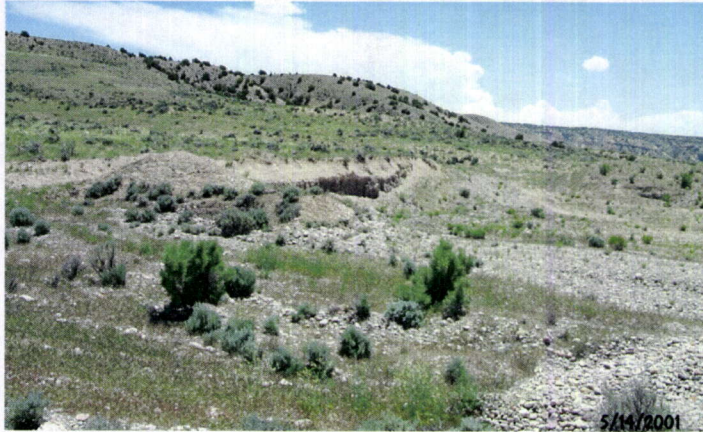
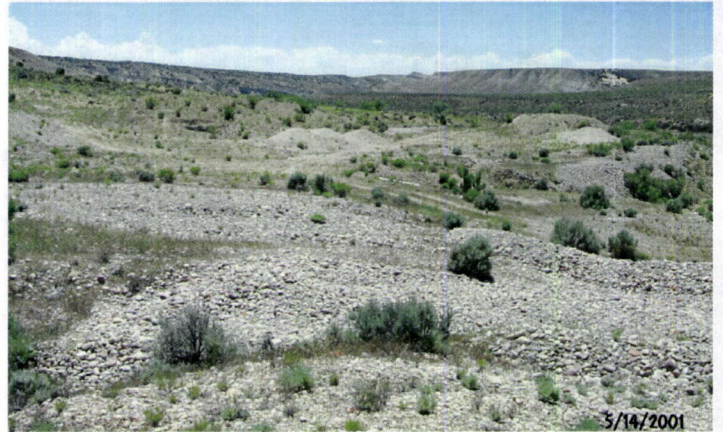
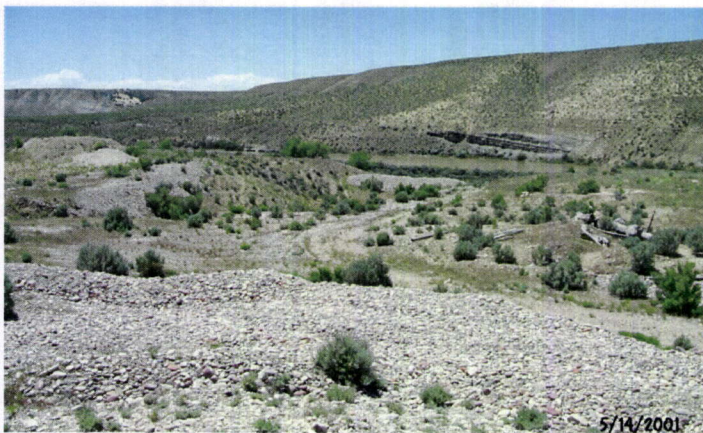
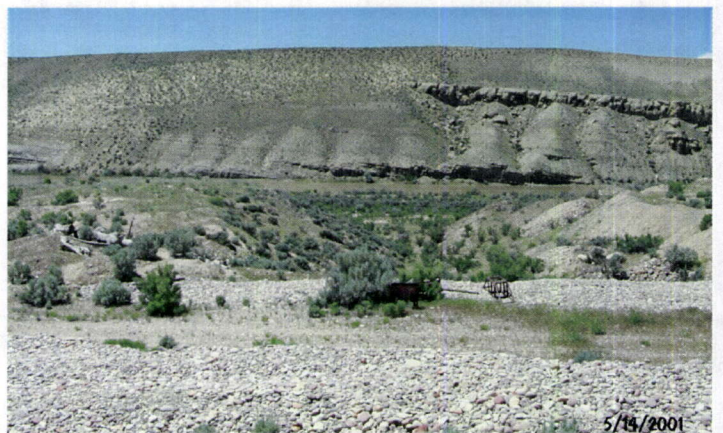
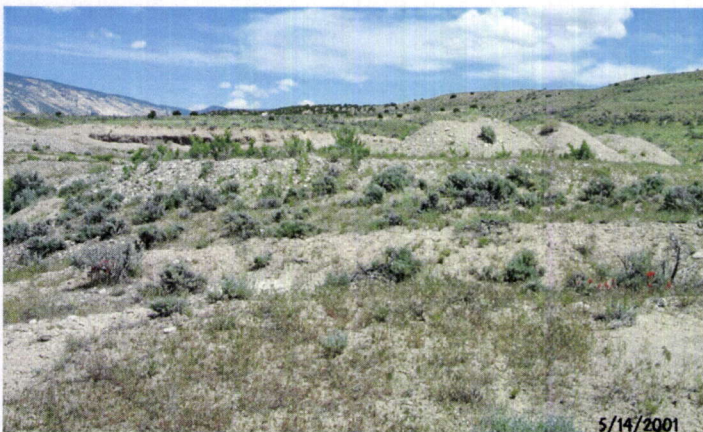
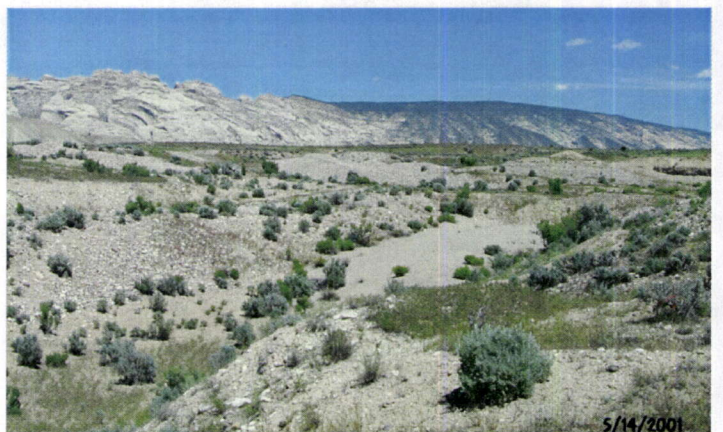
HIKO BELL ^{1/2}
FILE UNDER S/047/050
- OLD FILE RETIRED S/047/049

The Hiko Bell site does not have any visible structures or large equipment. The disturbances consist of gravel piles and the associated excavations, access roads, small cofferdams, and the drainage filled-in for the access road. One excavation has created a length of highwall. An access road leading down from the cofferdam and west to the river is also part of the reclamation responsibility.

Photographs were taken overlooking the site from the southwest to the west. Additional photos were taken from the southwest corner of this site looking towards the east and north. The southern border of the Hiko Bell site is also marked by a drainage.

Reclamation of this site will include regrading the road sections and ripping the roads if needed. The gravel and cobble piles will need to be regraded against the highwall and covered with available soil material. Other gravel piles will need to be regraded into the excavations. The filled-in drainage will need to be restored by removing the fill to the approximate pre-mining configuration. The highwall will need to be backfilled to achieve a slope of 3h:1v.
